Developing Recommendations On The Technical Condition Of "Komi-Kasaba" Channel And Its Improvement.

Parameters of the Komi-Kasaba channel

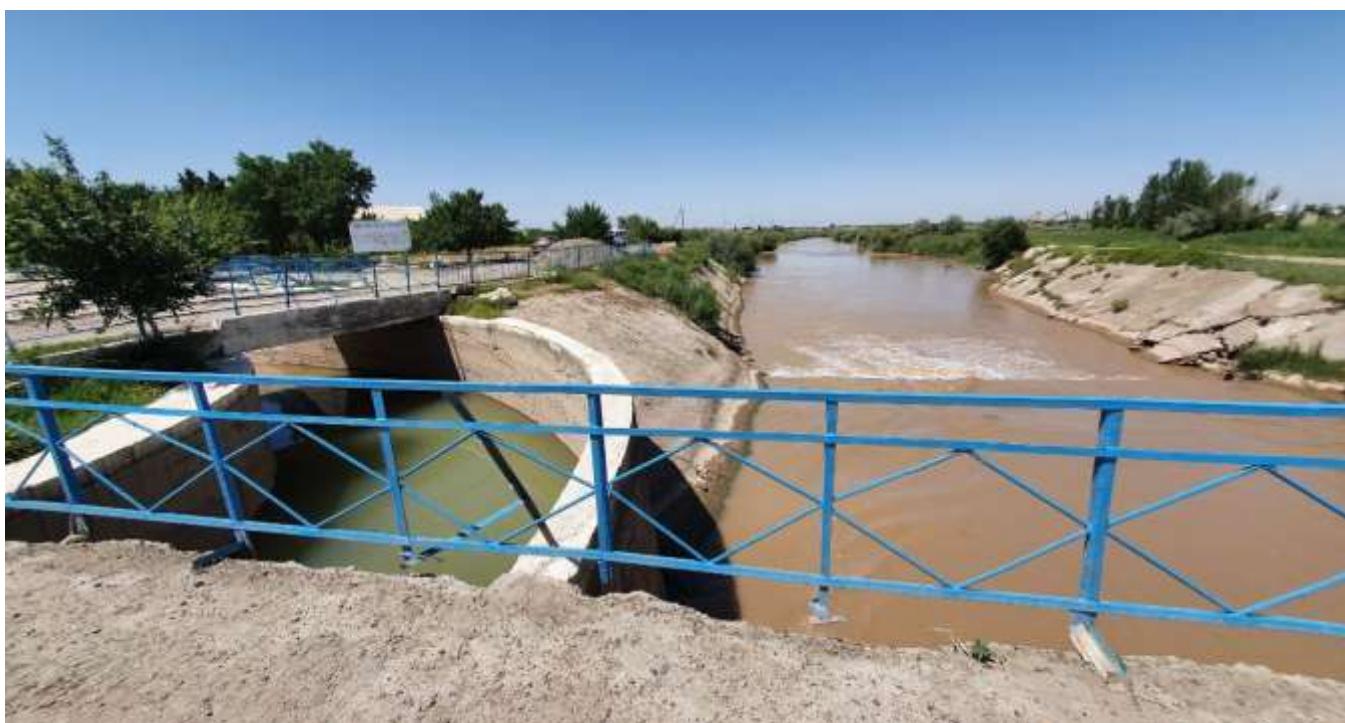
- the technical condition of the field connected to 2341 is unsatisfactory, it is technically faulty. The concrete of the inter-farm canal "Komi kasaba" has become old and unusable. The last capital repair was in 1945. Komi kasaba of Vobkent receives water from the Komi Aka hydroelectric point located in the PK 142

Fig. 1 Cases of failure of hydrogel concrete coating
