Inspection And Diagnostics Of Railway Reinforced Concrete Bridge In Andijan-Khanabad Peregon

The article presents practical recommendations for determining the load-carrying capacity of the railway reinforced concrete bridge located at 346+605 km of the Andijan railway distance Andijan-Khanabad. To ensure the safety of vehicles, it is recommended to build a new bridge or replace the main part of the bridge.

Setting the task. This article examines the inspection and diagnostics of the 346+605 km railway reinforced concrete bridge located on the Andijan-Khanabad railway section in Andijan region in 2022. For this purpose, it is necessary to identify existing defects and damages in the railway reinforced concrete bridge, and to analyze the condition of existing defects in each structural element of the bridge. As a result, the technical and operational condition of the bridge constructions is evaluated according to the load-carrying capacity, and the possibility of future exploitation is determined.

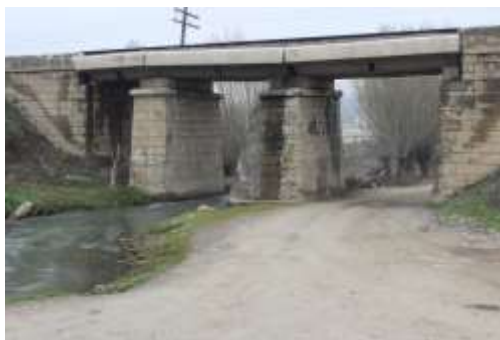
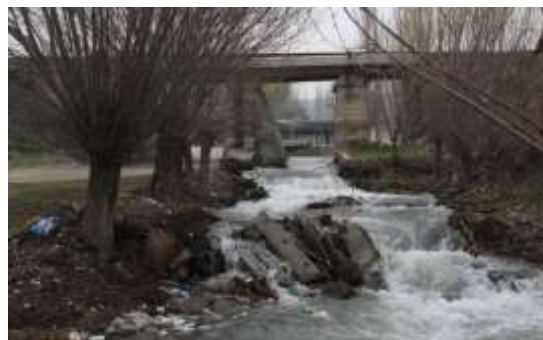
Inspection and diagnostic results. The reinforced concrete railway bridge of 346+605 km located on the Andijan-Khanabad railway section of the Andijan railway distance was built in 1915 according to the scheme of 3.08+5.27+5.36 m. The total length of the bridge is 23.07 m. In 1997, the bridge intermediate device №557 (typical project) was replaced with a slab reinforced concrete intermediate device with simple reinforcement, and it was calculated for the design load of CK 14 (Figures 1-3).

Figure 1. General view of the reinforced concrete railway bridge (right and left sides)

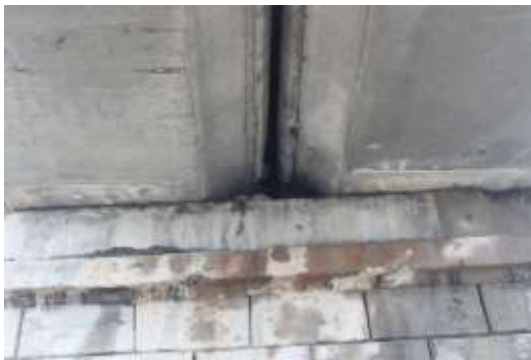
- In the zone near the deformation seams, there is partially damaged layer of concrete (Figure 5);

Figure 5. Span - slab, reinforced concrete

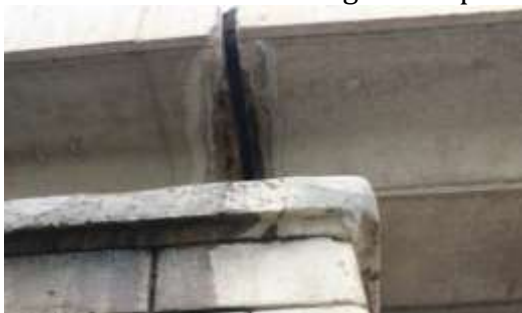
- Stoppies slots are not covered with concrete;
- water escape pipes are reduced or damaged;
- Metal sheets on longitudinal and transvegar deformation between the intermediate device blocks and are strongly corrosion (figure 6-7);
- Due to the flaw of metal sheet in the Andijan station on the side base, the ballast is down due to the defective state (not allowed according to norms);

Figure 6. Salinity

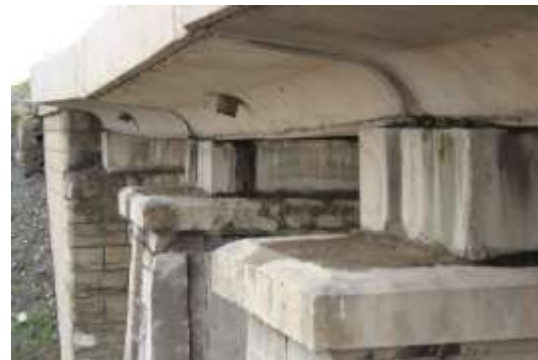
Figure 7. The place of water flow near and in deformation seams

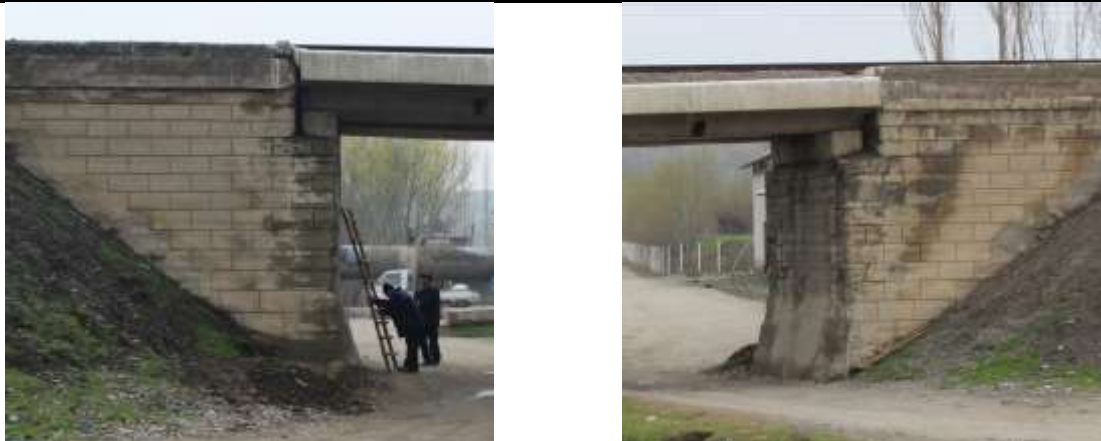
- The decline base is traces of water flow and the supports are vertically deformed;
- Farmed fields gravel and flaven bases were corrased with waste and deformation in demonstrations in foreign bases (Figure 8);
- Drain is partially damaged.

Figure 8. The appearance of the edge support № 4

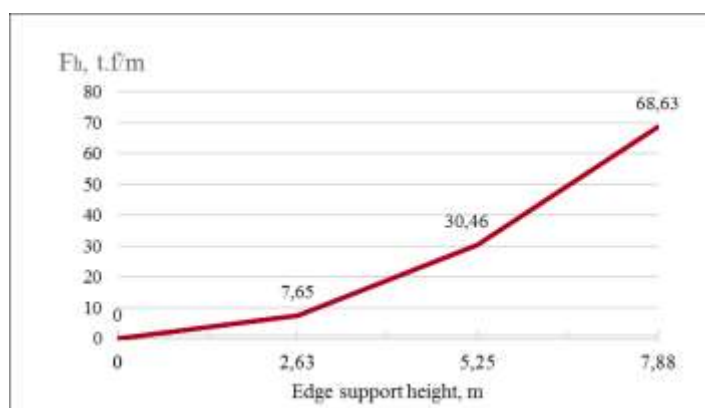
$$F_h = \frac{1}{2} p_h h_x b,$$

Figure 9. Graph The schedule of the grounding the normal pressure on the base base dependence on the base height

The graph can be seen that the ground is increasingly increases to the target horizontal pressure to increase the base height of the target. The base body of the ground pressure of the ground
