Conveyor belt structure and mode of operation in mines

ABSTRACT

The paper discusses the results of a study carried out to determine the thermal condition of a conveyor power unit using a thermal imaging camera. The tests covered conveyors in the main haulage system carrying coal from a longwall. The measurements were taken with a thermal imaging diagnostic method which measures infrared radiation emitted by an object. This technology provides a means of assessing the imminence and severity of a possible failure or damage. The method is a non-contact measuring technique and offers great advantages in an underground mine. The thermograms were analysed by comparing the temperature distribution. An analysis of the operating time of the conveyors was also carried out and the causes of the thermal condition were determined. The main purpose of the research was to detect changes in thermal state during the operation of a belt conveyor that could indicate failure and permit early maintenance and eliminate the chance of a fire. The article also discusses the construction and principle of operation of a thermal imaging camera. The findings obtained from the research analysis on determining

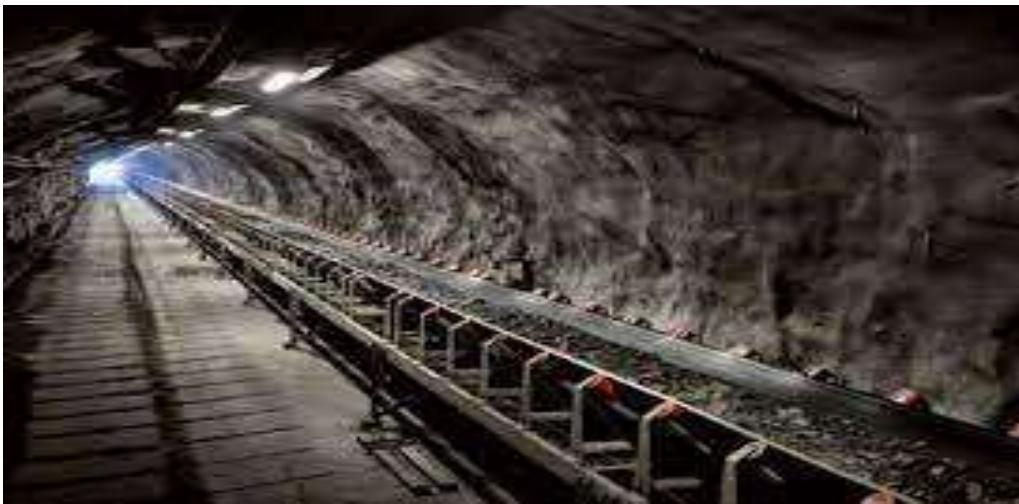
were recorded for gearbox II and had a significant effect on the maximum temperature of the entire drive. For the PT-2 conveyor drive unit located in the collective ramp on E/III, the lowest of the maximum temperatures at around 29.9–34.2 °C. was recorded. Higher temperatures (50.1–54.6 °C) obtained from the measurements were characteristic of the PT-1 conveyor drive located in the belt gallery. In contrast, the same type of conveyor PT-3 achieved temperatures of 42.8–47.6 °C. In further measurements, temperatures remained between 47.2 and 52.6 °C for the drive unit of the PT-4 conveyor located in the eastern drift III. The presented comparison of temperatures obtained for the conveyor drive unit (Figure 9) shows that the PT-5 conveyor drive has the highest temperatures, remaining at 62.7 °C, which means it exceeded the critical value of 60 °C. This may indicate intensive use of the conveyor. The analysed measurements for the PT-II conveyor drive were at a level of 48.3–51.0 °C, which indicates correct operation. For the PT-I conveyor, temperatures ranging from 38.0 to 43.3 °C were recorded. A key element in the overall test procedure is to determine the values at which alarm states associated with temperatures exceeding 60 °C can be identified. The determination of these values is based on a statistical analysis of the results obtained for the main substitution tested. A summary of the measurements obtained for the main drive units are shown, with the temperature warning levels marked by a red dashed line.
