Studying rock slope stability for the northwestern plunge of Hamrin Anticline fold / North Iraq

ABSTRACT

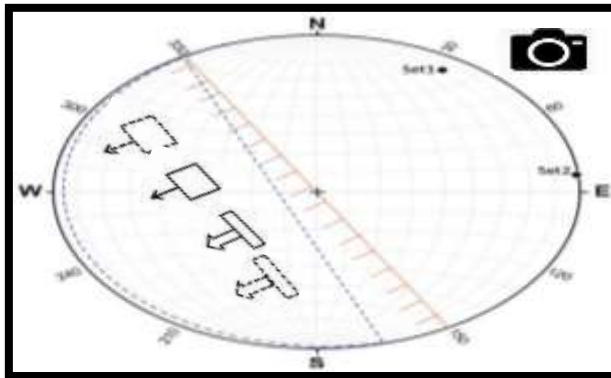
Fig.3: diagram showing the relationship between the slope and the layers and discontinuities, as well as the failure types of station No. (1), the direction of photography (north-east).

This station is located in the northwestern part of the Hamrin convex fold, according to the coordinates N ($35^{\circ} 03'09''$) and E ($35^{\circ}33' 43''$), and it consists of a slope whose attitude is ($240^{\circ}/OH-90^{\circ}$) with a height of about (4m) and a width of about (2m), and the type of slope is of a parallel type where the value of the angle of deviation is ($d = 10^{\circ}$), plate (1), the attitude of the layers is ($250^{\circ}/05^{\circ}$), and the limestone layer has a compressive strength of (14.294) MPa.

In the limestone layer, there are two sets of joints, the first set (set1) with a frequency (2 per 2m) and an attitude ($212^{\circ}/80^{\circ}$), and the second set (set2) with a frequency (3 per 2.5 m) and an attitude ($264^{\circ}/89^{\circ}$).

Through the field survey, it was found that the collapse of the type of rockfall and the occurrence of the collapse of the toppling type, and the expected collapse of the type of toppling collapse and rockfall, due to the presence of the vertical and hanged slope, which leads to the cohesion between the discontinuity being zero (0) and the fall of the rock mass towards the bottom of the slope with the effect of the weight of the rock mass, and the occurrence and possible rockfalls were represented in the spatial projection diagram shown in Figure (3)

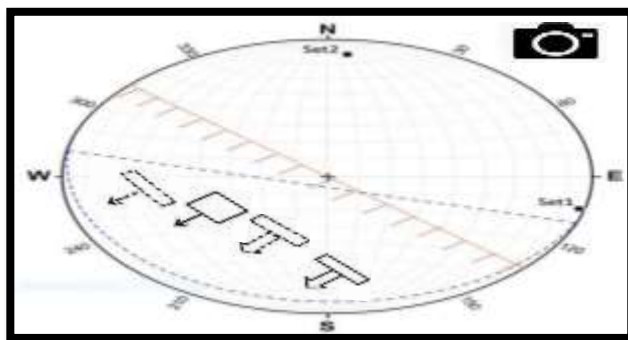
Fig.4: diagram showing the relationship between the slope and the layers and discontinuities, as well as the failure types of station No. (2), the direction of photography (north-east).

This station is located in the northwestern part of the Hamrin convex fold, and at the following coordinates: N ($35^{\circ}03'12''$) and E ($40^{\circ}33'43''$), and its altitude is above sea level (139m), It consists of a slope with a height of about (7m) and a width of about (25 m), and its attitude ($222^{\circ}/OH-90^{\circ}$), plate (2), and the attitude of the layers in this station ($017^{\circ}/10^{\circ}$), and the slope is of a lateral oblique type where the value of the deflection angle is ($d=25^{\circ}$), and the limestone layer appears with fine grains in light color, with a thickness of about (1m) and with a weak compressive strength with a moderate value of (11.400) MPa.

The limestone layer is cut by two sets of joints, the first set (set1) with attitude ($284/88$) and frequency = (3 per 2.5m), and the second set (set2) with attitude ($185/78$) and frequency = (3 per 2m), and the internal friction angle ($\phi=33^{\circ}$). Field-survey, it appears that the collapse is of rockfall and overhang because the slope is vertical to the overhanging due to the presence of a weakly weathering-resistant marl layer, whose cohesion resistance is ($C=13.21$) kPa and its internal friction angle ($\phi=21^{\circ}$), which led to the release of the weight from the center of the supports and the cohesion between the interruptions became zero, which leads to the overturning of the rock mass. The cohesion

represented in the spatial projection diagram, Figure (4).

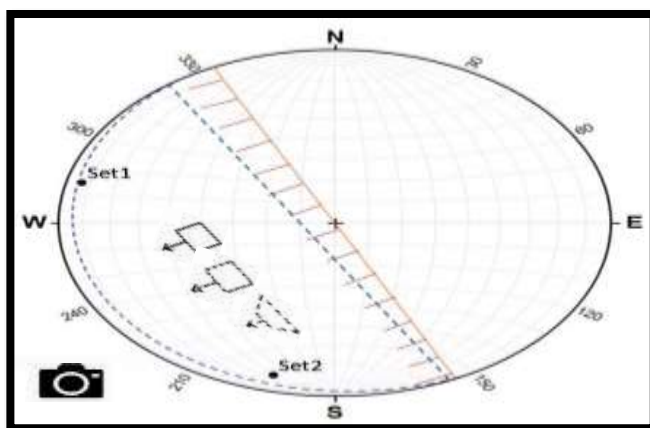
Fig.5: diagram showing the relationship between the slope and the layers and discontinuities, as well as the failure types of station No. (3), the direction of photography (south-west).

This station is located in the northwestern part of the Hamrin convex fold, at the following coordinates: N(03°16'35) and E (43°33'39'), and its height is from sea level (139m). It consists of a slope with a height of about (8 m) and a width of about (30 m), and its attitude (064°/OH-90°), plate (3), and the attitude of the layers in this station (240°/07°), the plate, and the type of the slope is of the parallel type because the angle of deviation is (d=4°), and the limestone layers appear with fine grains in a light color and with a thickness of about (3.5m), and with a moderately strong compressive strength of (13.330) MPa.

The limestone layer is cut by two sets of joints, the first set (set1) with an attitude (014°/80°),

frequency =(4 per 2m), and the second set (set2) with an attitude (104°/83°), frequency =(3 per 2m), and the value of the internal friction angle ($\phi=31^\circ$). In the field, it appears that the collapses occurring in it are of the type of rockfall, and the collapses that are expected to occur are of the wedge slip type and the type of rockfall, due to the presence of the vertical and overhanging slope (OH) and when the cohesion between the discontinuities becomes zero (0) the mass is allowed to fall down the slope due to the weight of its weight, and the occurrence and possible collapses were represented in the spatial projection diagram, Figure (5)
