## Assessment Of the Ground and Construction Condition of the Arch "Ak-Saray" in Shakhrisabz

T.F.N., Dots. Shadmanova Z.S  
Master Karaboev D. A.

Tashkent Institute of Architecture and Construction  
Tashkent Institute of Architecture and Construction

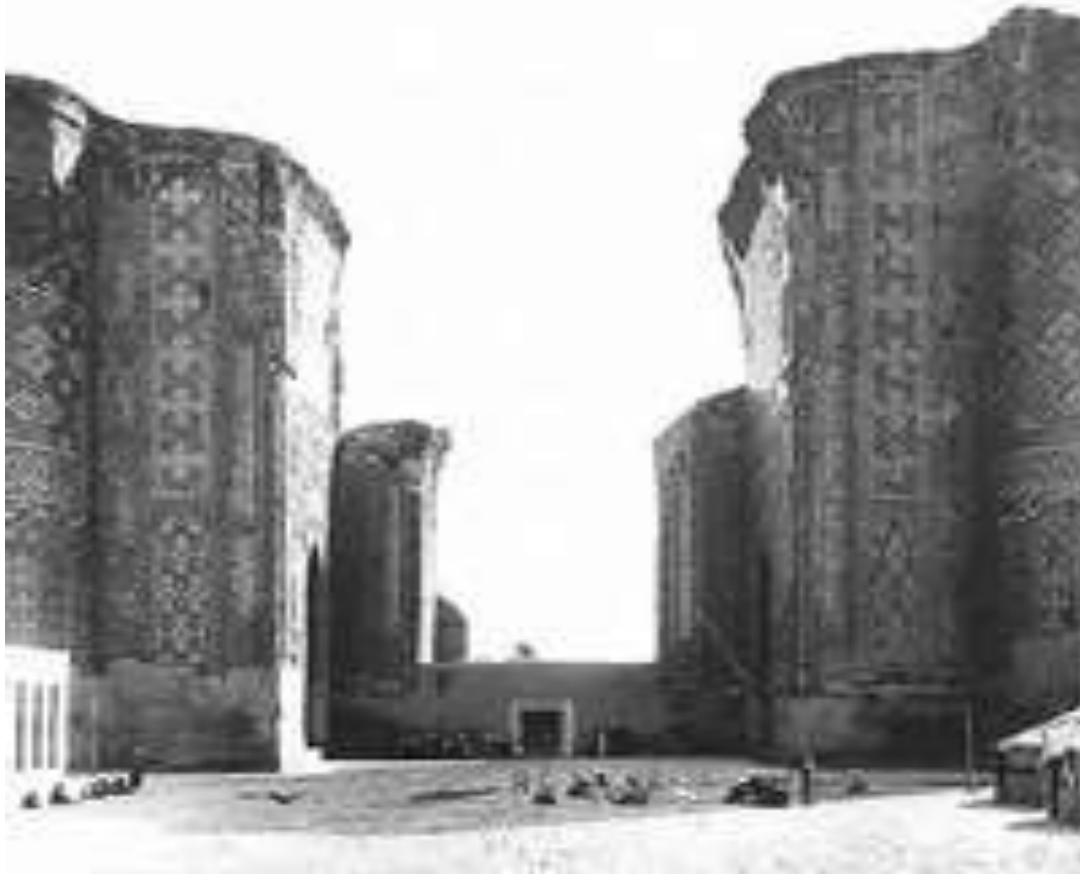
To date, only two foundations of a huge roof have survived from the White Palace arch. However, this surviving part of the roof is a testament to the majesty and grandeur of the White House arch.

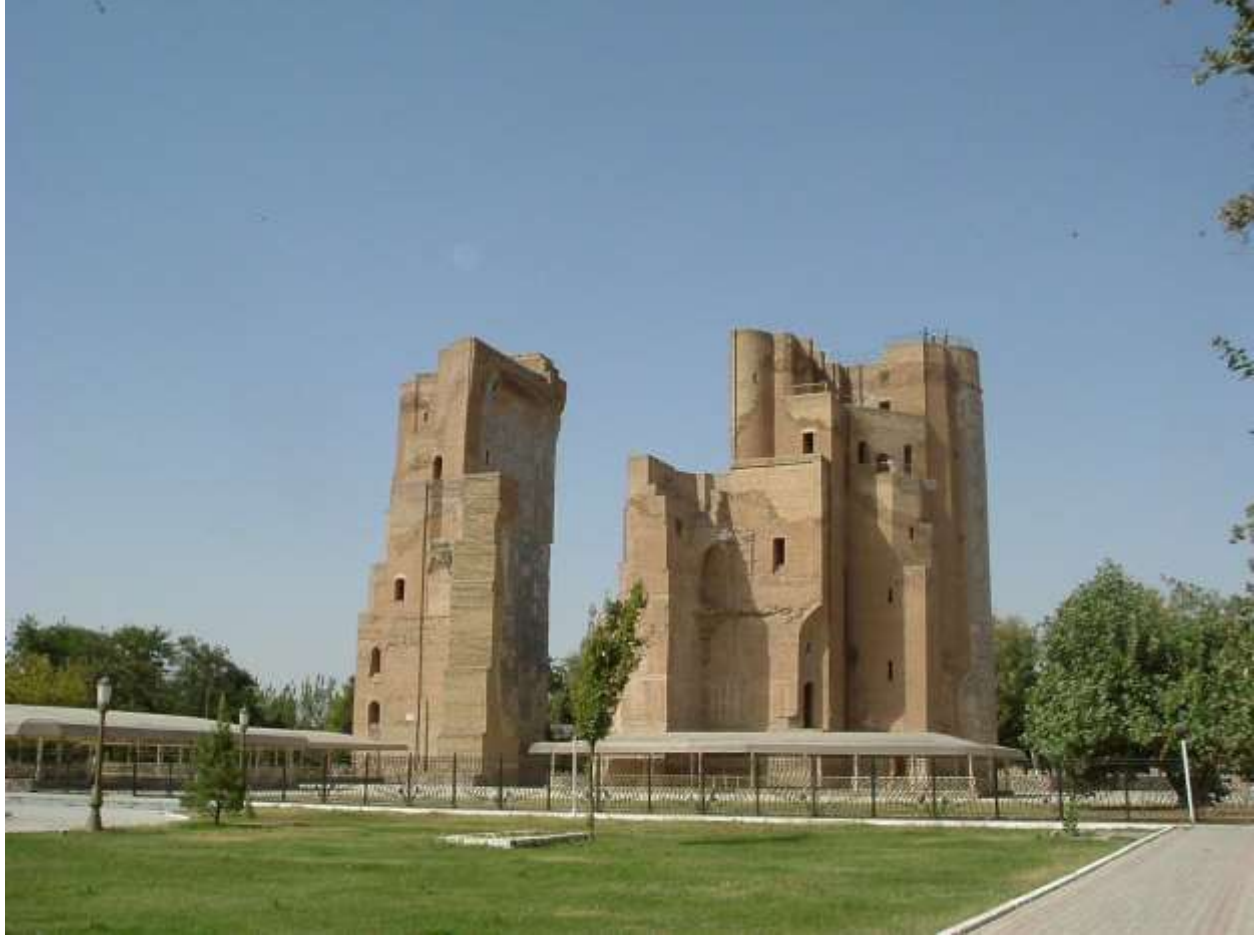
**The eastern** roof has been preserved to a height of 35 m above ground level. The White Palace arch is built of a simple square-shaped baked brick mixture of gypsum. The brick walls of the roof are in good condition, but the brickwork of the small porch is preserved in an unsatisfactory condition. As a result of the deflection of this block from the main roof to the south, a change of the upper part caused a crack of 60 cm. The crack was deep and continued to the foundation. In the southern part there are cracks up to 10 cm. Due to the lack of roofing, the upper part of the brick pile lost its load-

bearing capacity due to natural impacts (precipitation) of 1-1.5 m.

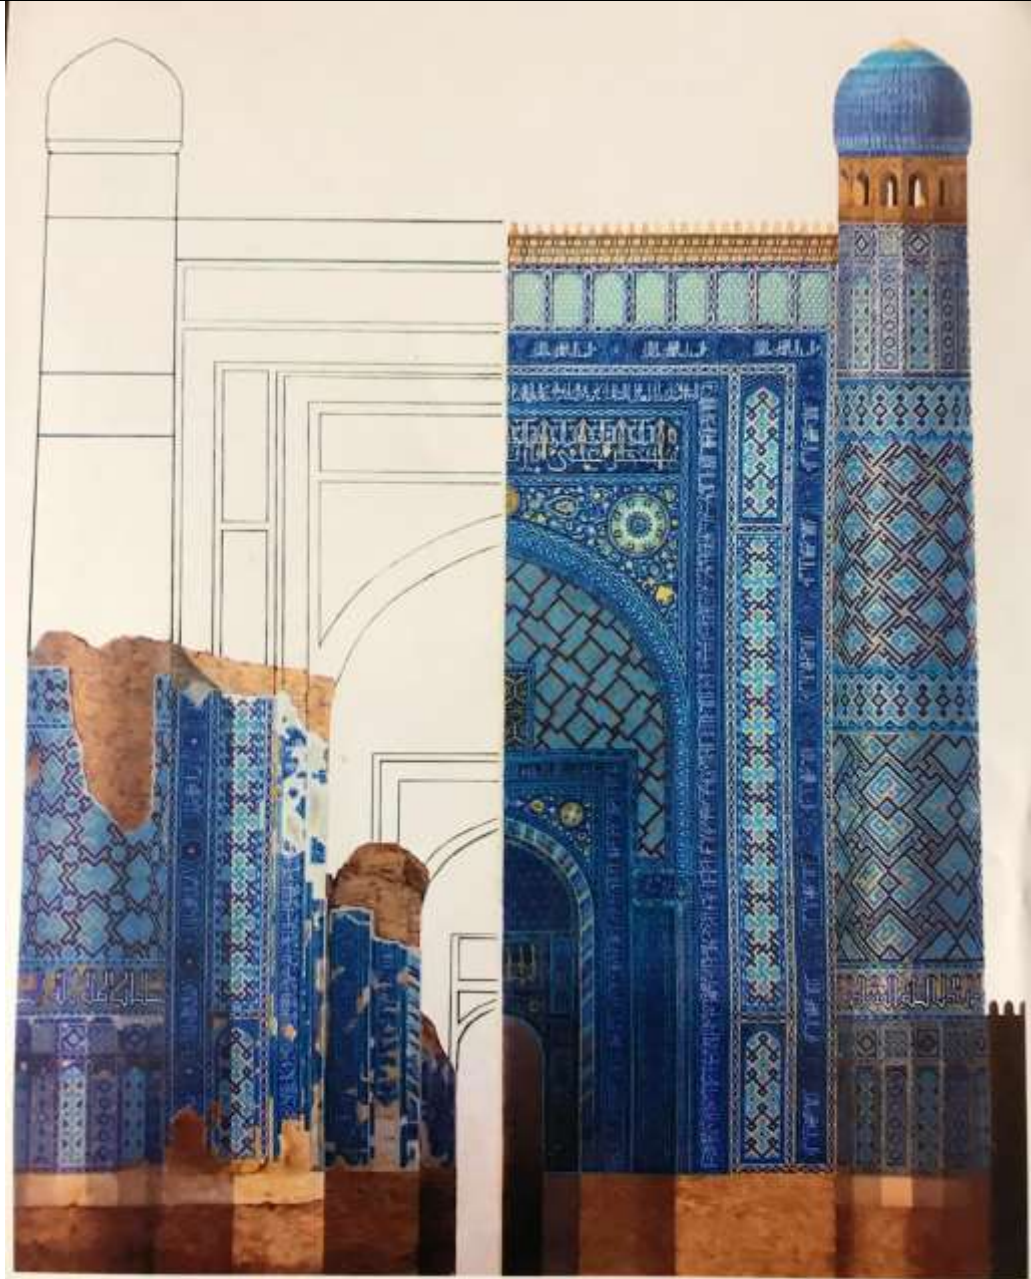
**West Roof This** roof has survived to a height of 38 m above ground level. The brick walls of the roof walls are in good condition. In the preserved part of the large porch, there are 2 cracks visible from the courtyard facade. Here, too, the upper part of the roof brick pile has lost its initial load-bearing capacity. The brickwork of the foundation of the bouquet is well preserved. However, the original marble coatings of the foundation were lost.
