Defects And Destruction On Roads With Cement Concrete Pavements

The article analyzes various types of defects on cement concrete pavements, gives recommendations for their elimination during operation.

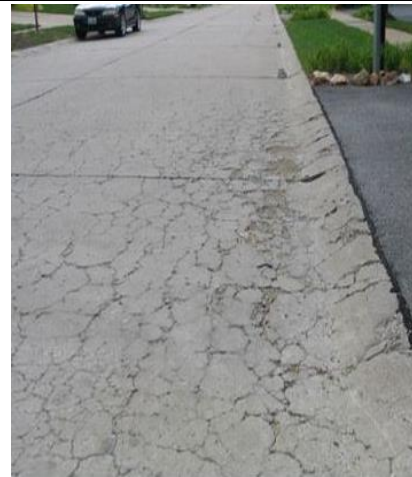
Surface delamination of concrete pavements in appearance is closely related to the formation of deposits and delaminations. However, the failure mechanism is different, as discussed in detail in this one. Delamination can be considered as the development of a horizontal crack within the slab, which leads to separation of the surface layer to a depth of 1.25 to 5 cm from the rest of the concrete.

Depending on the underlying cause of the dissection, the dissection may be localized or widespread. Although delamination is typically seen near pavement joints and can extend 91 cm or more into the slab, it can also occur anywhere on the slab.

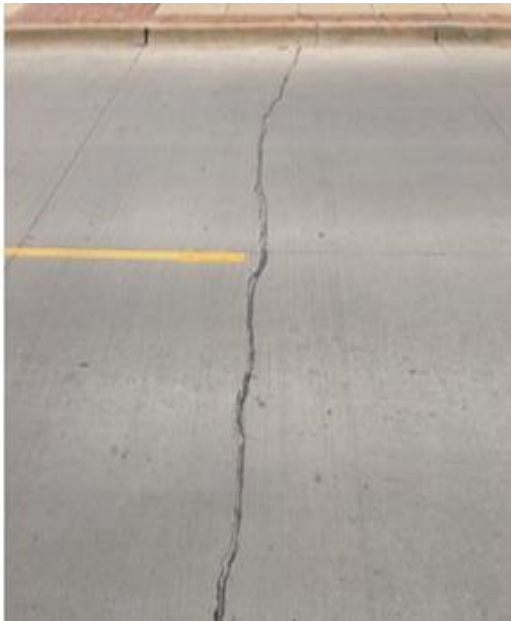
Transverse and diagonal cracks

Transverse cracks, also referred to as mid-panel or slab cracks, are oriented transversely across the pavement and perpendicular to the centerline of the pavement. Diagonal cracks are oriented obliquely across the slab at an angle of approximately 30 to 60 degrees from the centerline of the pavement.

Regardless of orientation, these types of cracks differ from mapping cracks or other surface cracks in that they are distinct cracks that typically run through the entire thickness of the slab.

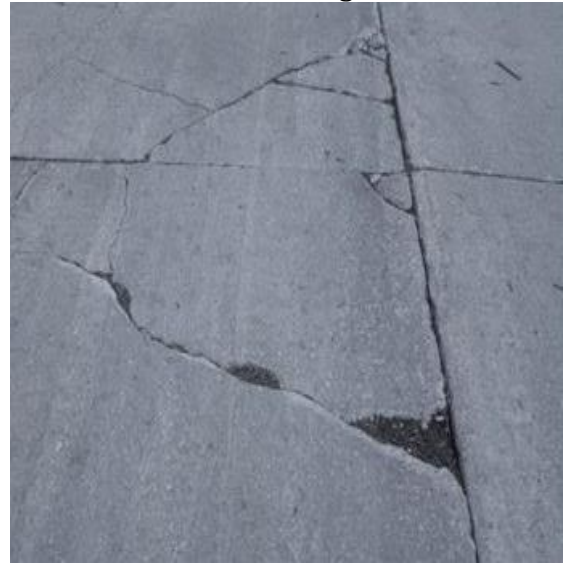
Corner cracks (also known as "corner breaks") are well-defined full-depth cracks in a bonded concrete pavement. Corner cracks cross adjacent transverse and longitudinal joints at an angle of approximately 45 degrees to the direction of travel. The length of the sides is rarely less than 30 cm and is always less than half the width of the slab (by definition) on each

side of the corner. Fractures with longer branches are considered diagonal cracks..
